Root Cause Analysis of Thin Gate Oxide Degradation during Fabrication of Advanced CMOS ULSI Circuits

Sang U. Kim*

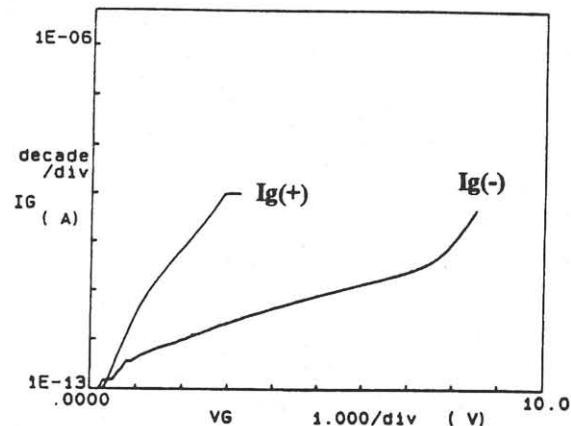
Fig. 1 shows a typical I_g - V_g characteristics of the p-channel transistor gate oxide leakage caused by plasma damage. It exhibits an asymmetric behavior, significantly higher gate oxide leakage with a positive bias voltage. It is similar to a p-n diode characteristic, a large current with V_g

Fig. 1 : A p-n diode characteristic, a large current with V_g (forward bias) and a small current with V_g (reverse bias).

positive (forward bias) and a small current with V_g negative (reverse bias). Next, it was electrically determined where the gate oxide leakage originates in the transistor. With the measurement conditions as shown in Fig. 2, if $I_g = I_{nw}$, it signifies presence of a defect in the channel region, if $I_g = I_s$, a defect in the source region, and if $I_g = I_d$, a defect in the drain region. This technique was applied to both n+ and p+ gate oxides damaged by plasma charging. A surprise result was obtained, especially for P+ gate oxides. It was found that n+ gate oxide leakage occurred predominantly at the source or drain edge of the gate oxide, even for the largest (100um x 100um) transistor. On the other hand, p+ gate oxide leakage occurred predominantly in the channel region of the transistor, even for the minimum channel (20um x .32um) transistor. The implication of an area defect in such a small or edge intensive transistor was not expected since the plasma damage occurs at the highest field point which normally exists at the source and drain edge.

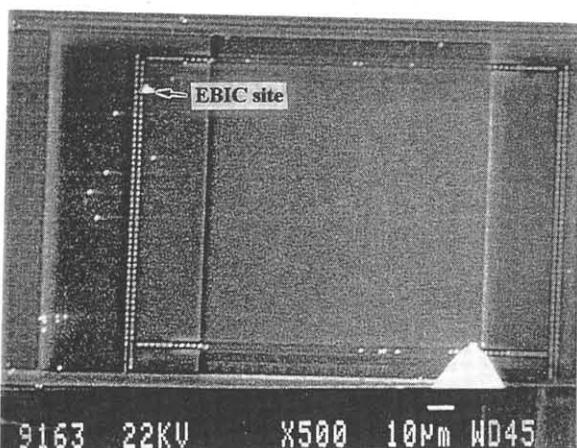
In order to confirm the electrical result, EBIC analysis was performed. EBIC can show not only where the gate oxide leakage originates, but more importantly, it can also localize or pinpoint the leakage site as shown in Fig. 3. The EBIC results were in complete agreement with the electrical results. For n+ gate oxides, the EBIC emission sites indicated by hot spots occurred predominantly at the edge, not at channel area even for the largest area (100um x 100um) transistor as shown in Fig. 3a. For p+ gate oxides, the emission sites occurred predominantly at the channel area, not at the edges even for the minimum channel length (.32um) transistor, as shown in Fig. 3b. Notice a very small localized nature of the emission site. This clearly indicates that some sort of process defects are formed in the p+ channel gate oxides, contributing to the high susceptibility to plasma charging damage.

Fig. 3a: For the n+ gates, the EBIC emission spot occurs predominantly at the source and drain edge of the transistor, even for the largest area (100um x 100um) transistor as shown.

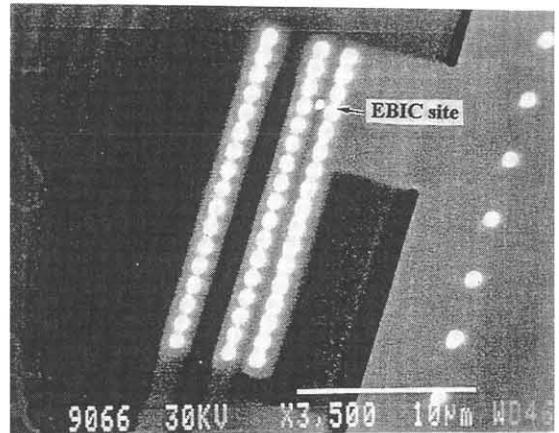
Fig. 3b: For the p+ gates, the emission spot occurs predominantly at the channel area, not at the edge even for the minimum channel (.32um) transistor. It occurs at the center of the minimum transistor.

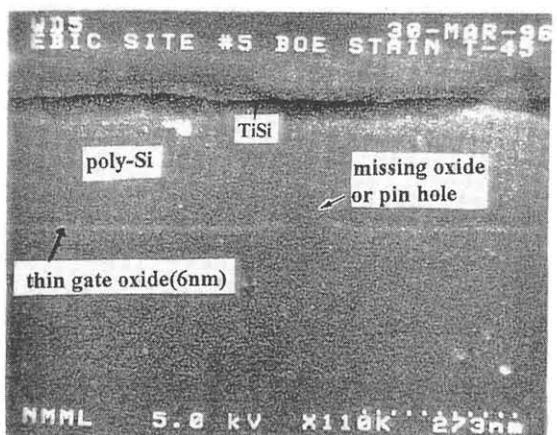
The next step was to perform FIB cross section through the EBIC emission sites to determine the nature of the defect. The FIB cross section was found to be extremely difficult to do because the emission site where the gate oxide leakage originates was very small, ~500A or less in diameter. The cross section was performed in several increments. For each increment, the sample was taken out of the FIB machine, and was observed under a high resolution SEM. This procedure was repeated for each incremental ion milling. Only two out of eight samples were successful. One of these is shown in Fig. 4. Notice a missing gate oxide or a pin hole (~500A) created by plasma damage. A slight decorative etching was done to highlight the image. TEM cross section was not successful because of the difficulties involved in the sample preparation for such a small cross section area.

Fig. 4: FIB cross section through the EBIC emission site. A missing oxide or a pin hole created during plasma charging is clearly seen. Boron diffusion through the pin hole can form a p-n diode.

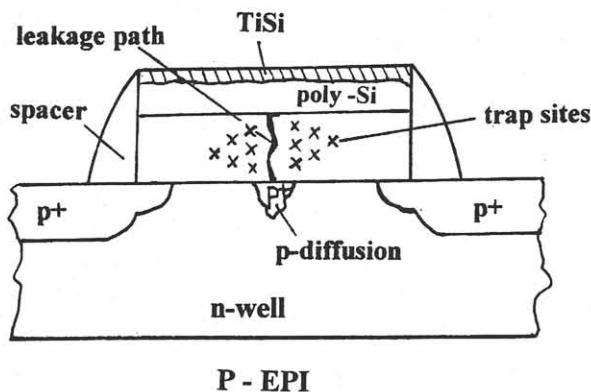
It was conclusive from the EBIC and FIB cross section results that the enhanced p+ gate oxide degradation was due to a combination of process defect and plasma process charging. The defect, however, was not a random process induced defect. It is very plausible for some boron atoms in the p+-poly gate to diffuse through the pin hole into the n-well during the rupture process, and form a very small localized p-n junction which gives rise to an asymmetric electrical behavior as shown in Fig. 1. Therefore, the defect results from a localized p-n diode formation. The question is, then, how does such a defect form at the center of .32um minimum channel area? The defect formation is based on boron incorporation into the p+ gate oxide. It has been reported that the boron diffusion into the gate oxide of PMOS transistor is non-uniform across the channel, significantly higher at the center than at the source and drain edges[4]. The boron atoms diffused into the gate oxide are known to generate charge trapping sites[5], and thus the peak trap density must also occur at the center of the channel. These trapping centers may give rise to a localized weak spot in the gate oxide. During plasma charging, a large gate oxide leakage current may develop at the very small, localized weak spot where the highest boron concentration (or trap centers) exists. As a result, the thin gate oxide may be ruptured or melted due to excessive, localized heating, creating a pin hole as shown by the FIB cross section in Fig. 4. Some B atoms can readily diffuse through the pin hole into n-well below during the localized heating, forming a point contact (~500A) p-n diode. The p-n diode model is schematically illustrated in Fig.5. The p-n diode so formed is non-ideal, and its current varies,

Fig. 5: A schematic illustration of boron induced defect formation. A point contact p-n diode is formed by boron diffusion through the very small, localized pin hole into n-well. The pin hole or a missing gate oxide results from excessive, localized heating as a result of a high gate current flow during plasma charging. The pin hole occurs near the center of the channel where highest concentration of boron induced trap sites occur. See the text for details.

depending on the amount of boron diffusion into the n-well and the pin hole area. The asymmetric Ig-Vg characteristic and other bias temperature stress results reported in the literature can be easily explained by the model. The positive gate bias is always the worst condition since with positive Vg on the gate, the p-n diode is forward biased, while a much smaller current flows with a negative Vg since the diode is reverse biased. The Ig-Vg characteristic, especially Vg positive as shown in Fig. 1 is often misinterpreted as SILC. It is not. It is a forward biased p-n diode current as shown here. As for the n+ gate oxides, the As or P induced defect formation in such oxides is not known. As or P atoms still can diffuse into the source and drain edge in the case of a severe plasma charging, creating a leakage path. However, the boron induced defects were found to be much more susceptible to plasma charging, causing an enhanced p+ gate oxide degradation.

The p+ thin gate oxides of the advanced CMOS technology in manufacturing today were found to be inherently more susceptible to gate oxide degradation than n+ gate oxides. This is because the p+ oxide degradation is caused by a combination of the process induced defect and plasma charging. The defect, however, is not a random defect induced during process. The nature of the defect and its formation were determined by electrical and physical analysis such as EBIC and FIB cross section. The defect formation was modeled. The defects were found to result from boron incorporation into the p+ gate oxides during PMOS process. The p-channel gate oxide degradation will be worse with gate oxide scaling and may limit the device scaling. Therefore, future device scaling should consider a realistic gate oxide scaling limit which is based on p+ gate oxide degradation during high volume manufacturing of the advanced CMOS technology. The boron induced defect formation must be suppressed during high volume manufacturing.
