Root Cause Analysis of Thin Gate Oxide Degradation during Fabrication of Advanced CMOS ULSI Circuits

Sang U. Kim*

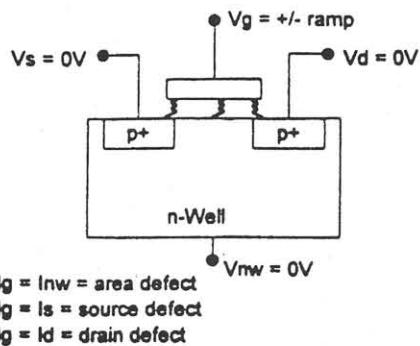
positive (forward bias) and a small current with V_g negative (reverse bias). Next, it was electrically determined where the gate oxide leakage originates in the transistor. With the measurement conditions as shown in Fig. 2, if $I_g = I_{nw}$, it signifies presence of a defect in the channel region, if $I_g = I_s$, a defect in the source region, and if $I_g = I_d$, a defect in the drain region. This technique was applied to both n+ and p+ gate oxides damaged by plasma charging. A surprise result was obtained, especially for P+ gate oxides. It was found that n+ gate oxide leakage occurred predominantly at the source or drain edge of the gate oxide, even for the largest (100um x 100um) transistor. On the other hand, p+ gate oxide leakage occurred predominantly in the channel region of the transistor, even for the minimum channel (20um x .32um) transistor. The implication of an area defect in such a small or edge intensive transistor was not expected since the plasma damage occurs at the highest field point which normally exists at the source and drain edge.

Fig. 2: Electrical measurement set-up to determine where the gate oxide leakage occurs.
